Flood Control Project Maintenance
2018 Structure Summary Report
Overall Unit and Item Ratings

San Joaquin County Flood Control and Water Conservation District

Flood Control Project Maintenance**Unit Cover Sheet****2018 Structure Inspection Results****San Joaquin County Flood Control and Water Conservation District**

Structure
Duck Creek Diversion Weir And Control Structure

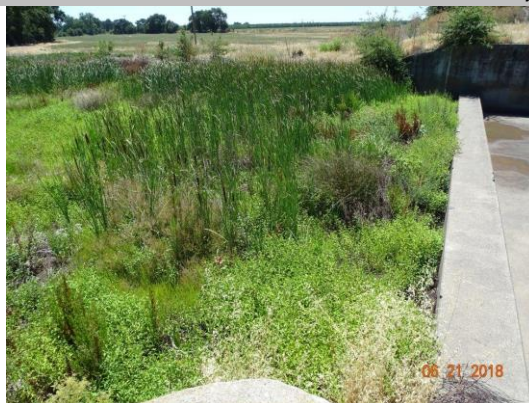
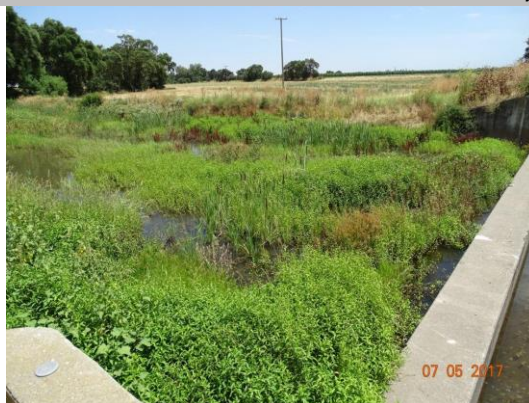
LM Start	0.00	Rating **	A	Issue No.	2
LM End	0.00	Issue Type +	Ma	Location *	
Category	Structures & Concrete Lined Channels			GPS Latitude/Longitude	
				Start	End
Item	Vegetation & Obstructions			37.938383 °	37.938383 °
				-120.990133 °	-120.990133 °
DWR ID	DWR_NA0017_5_t_2012_2				
Action/Comments					
Inspector Comments: There was minimal vegetation with new cat tails growth on the upstream side of the weir with minimal potential to impede flow.

View of the vegetation looking upstream of the weir. Summer 2018

View of the vegetation looking upstream of the weir. Summer 2017

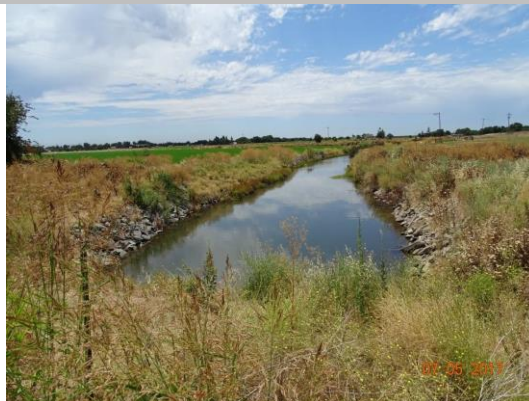
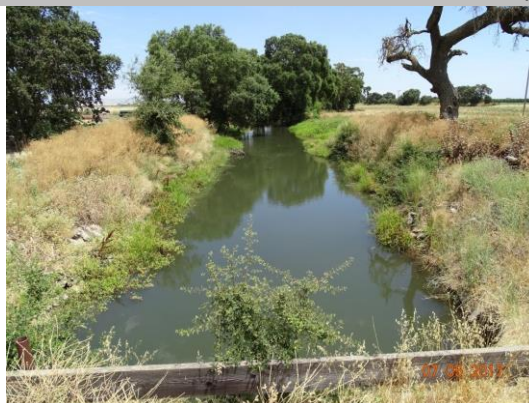
View of the revetments looking downstream of the weir.

View of the revetments looking upstream of the weir.

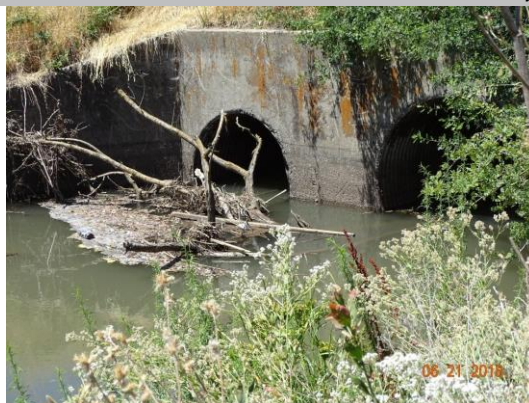
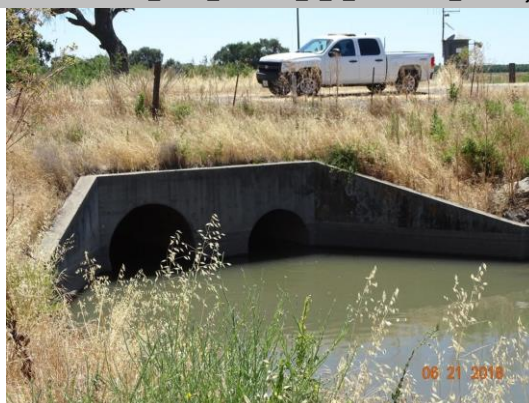
View of the inlet of the culvert. 2018

View of the outlet of the culvert. 2018

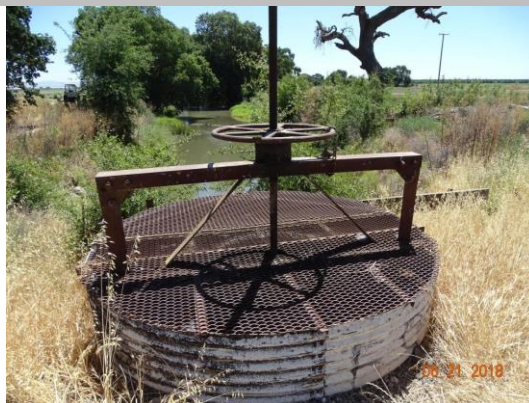
LM Start	0.00	Rating **	M	Issue No.	12	
LM End	0.00	Issue Type +	Ma	Location *		
Category	Structures & Concrete Lined Channels			GPS Latitude/Longitude		
				Start		End
Item	Sluice/Slide Gates			37.938383 °	37.938383 °	
				-120.990133 °	-120.990133 °	
DWR ID	DWR_NA0017_5_t_2012_12					
Action/Comments						
Inspector Comments: The gates appeared to be in good working condition. The screw gate needs to be maintained properly so that it can be turned with ease.

View of the slide gate. Summer 2018

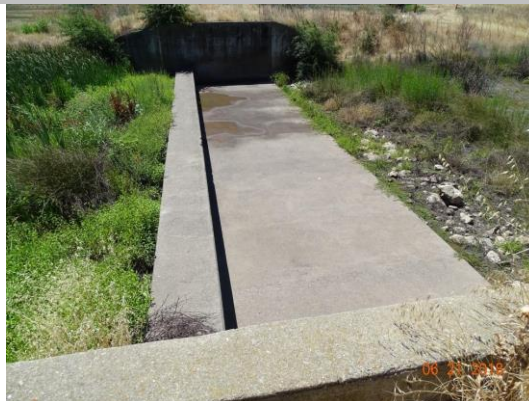
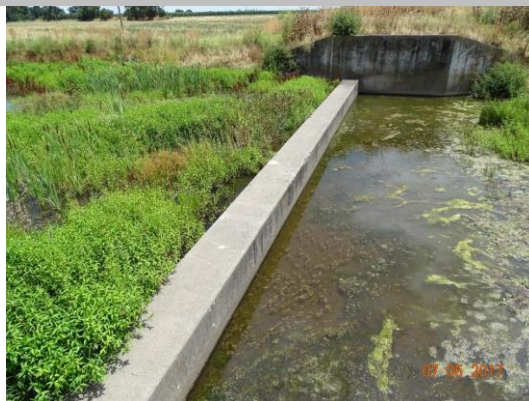
LM Start	0.00	Rating **	A	Issue No.	15
LM End	0.00	Issue Type +	Ma	Location *	
Category	Structures & Concrete Lined Channels			GPS Latitude/Longitude	
				Start	End
Item	Concrete Surfaces			37.938383 °	37.938383 °
				-120.990133 °	-120.990133 °
DWR ID	DWR_NA0017_5_t_ 2012_15				
Action/Comments					
Inspector Comments: The concrete surfaces had minor cracking and the surface was weathered but they didn't pose any threats to the integrity of the structure.

View of the weir and the concrete surface during 2018 inspection.

View of the weir and the concrete surface during 2017 inspection.

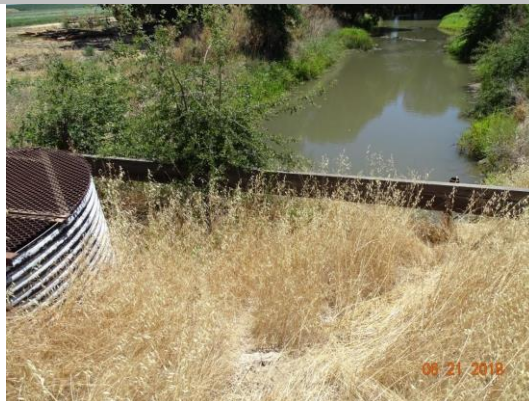
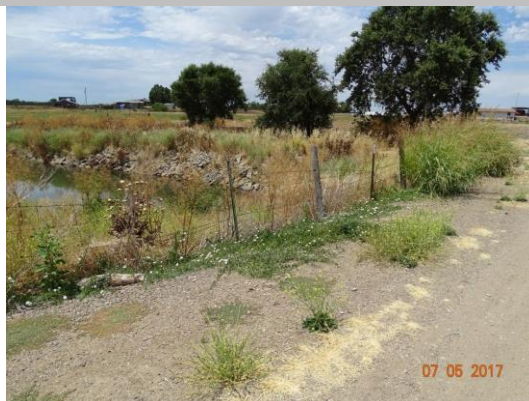
LM Start	0.00	Rating **	A	Issue No.	23
LM End	0.00	Issue Type +	Ma	Location *	
Category	Structures & Concrete Lined Channels	GPS Latitude/Longitude			
		Start		End	
Item	Safety	37.938383 °		37.938383 °	
		-120.990133 °		-120.990133 °	
DWR ID	DWR_NA0017_5_t_2012_23				
Action/Comments					
Inspector Comments: The wood railing top of the culvert appeared to provide adequate protection against fall hazards.

View of the railing on the top of the inlet culvert.

View of the fence at the outlet of the structure.

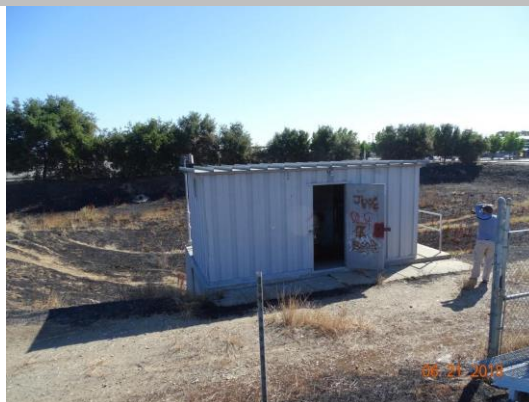
LM Start	0.00	Rating **	A	Issue No.	3
LM End	0.00	Issue Type +	Ma	Location *	
Category	Pump Stations			GPS Latitude/Longitude	
				Start	End
Item	Plant Building			37.989633 °	37.989633 °
				-121.266933 °	-121.266933 °
DWR ID	DWR_NA0017_18_t_2012_3				
Action/Comments					
Inspector Comments: The plant building was in good structural condition.

View of the pumping plant.

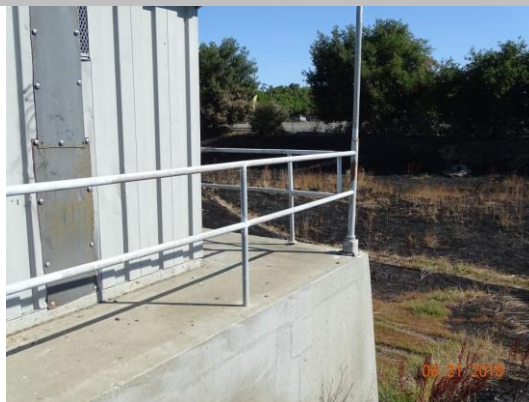
LM Start	0.00	Rating **	A	Issue No.	5	
LM End	0.00	Issue Type +	Ma	Location *		
Category	Pump Stations			GPS Latitude/Longitude		
				Start	End	
Item	Safety			37.989633	37.989633	
				-121.266933	-121.266933	
DWR ID	DWR_NA0017_18_t_2012_5					
Action/Comments						
Inspector Comments: There were no safety hazards found around the structure and the guard rails around the structure were in good condition.

View of the guard rails around the plant.

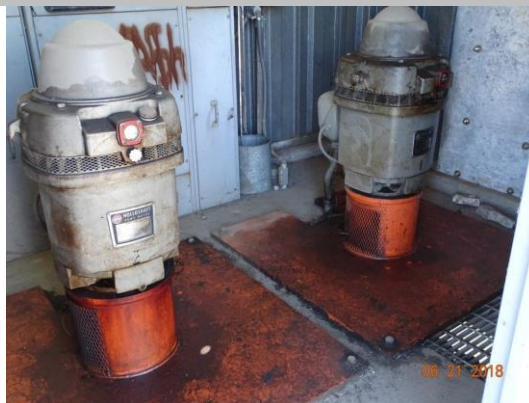
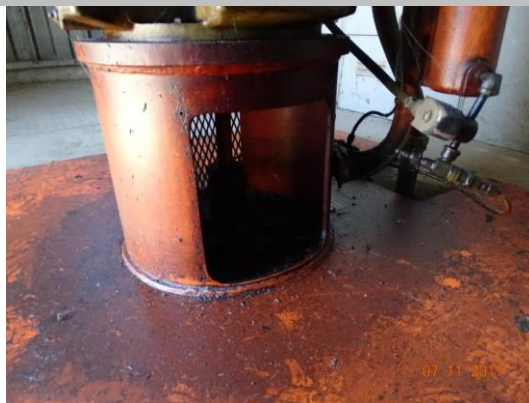
LM Start	0.00	Rating **	A	Issue No.	7
LM End	0.00	Issue Type +	Ma	Location *	
Category	Pump Stations			GPS Latitude/Longitude	
				Start	End
Item	Pumps			37.989633 °	37.989633 °
				-121.266933 °	-121.266933 °
DWR ID	DWR_NA0017_18_t_2012_7				
Action/Comments					
Inspector Comments: All pumps appeared to be in working condition and they were maintained, lubricated and tested periodically.

View of the pumps inside the plant.

View of the shaft under a pump.

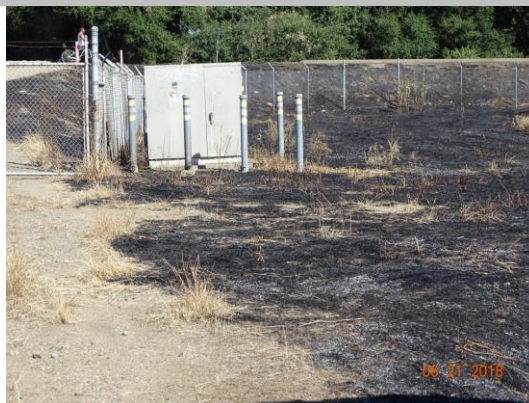
LM Start	0.00	Rating **	A	Issue No.	8
LM End	0.00	Issue Type +	Ma	Location *	
Category	Pump Stations	GPS Latitude/Longitude			
		Start	End		
Item	Power	37.989633 °		37.989633 °	
		-121.266933 °		-121.266933 °	
DWR ID	DWR_NA0017_18_t_2012_8				
Action/Comments					
Inspector Comments: The power source appeared to be safe and reliable.

View of the power source next to the pumping plant.

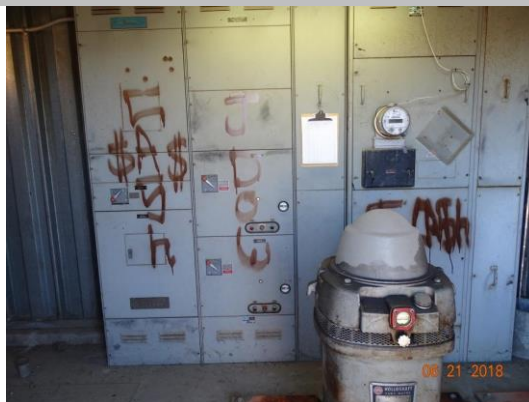
LM Start	0.00	Rating **	A	Issue No.	11
LM End	0.00	Issue Type +	Ma	Location *	
Category	Pump Stations			GPS Latitude/Longitude	
				Start	End
Item	Pump Control Systems			37.989633 °	37.989633 °
				-121.266933 °	-121.266933 °
DWR ID	DWR_NA0017_18_t_2012_11				
Action/Comments					
Inspector Comments: The pump control systems were maintained properly and appeared to be free of damage even though vandalism has occurred inside the plant building.

View of the pump control system inside the plant.

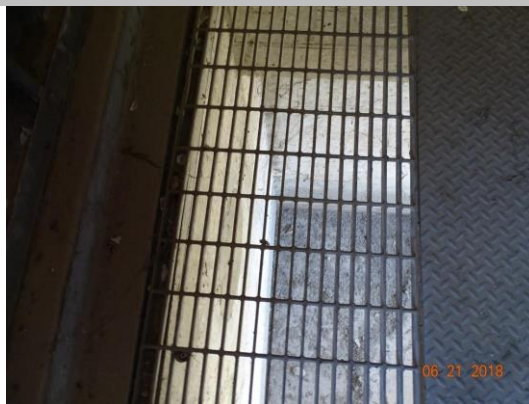
LM Start	0.00	Rating **	A	Issue No.	12
LM End	0.00	Issue Type +	Ma	Location *	
Category	Pump Stations			GPS Latitude/Longitude	
				Start	End
Item	Sumps/Wet Well			37.989633 °	37.989633 °
				-121.266933 °	-121.266933 °
DWR ID	DWR_NA0017_18_t_2012_12				
Action/Comments					
Inspector Comments: The wet well was completely dry and very little debris was present during inspection.

View of the wet well.

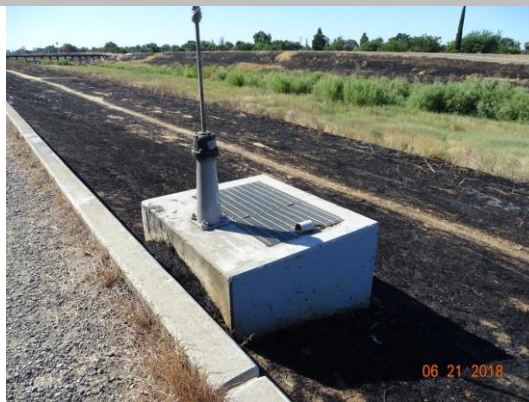
LM Start	0.00	Rating **	A	Issue No.	15
LM End	0.00	Issue Type +	Ma	Location *	
Category	Pump Stations			GPS Latitude/Longitude	
				Start	End
Item	Sluice / Slide Gates			37.989633 °	37.989633 °
				-121.266933 °	-121.266933 °
DWR ID	DWR_NA0017_18_t_2012_15				
Action/Comments					
Inspector Comments: The slide gate appeared to be in good condition. The wheel was removed for safety/security purposes.

View of the slide gate.

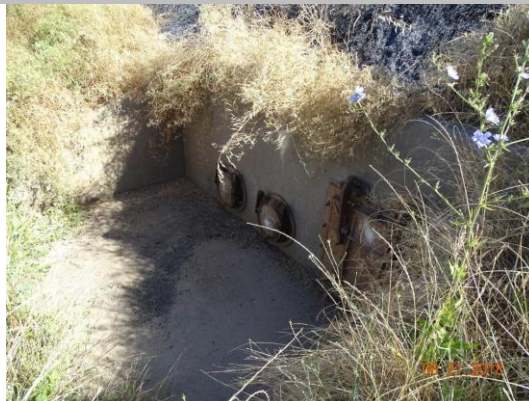
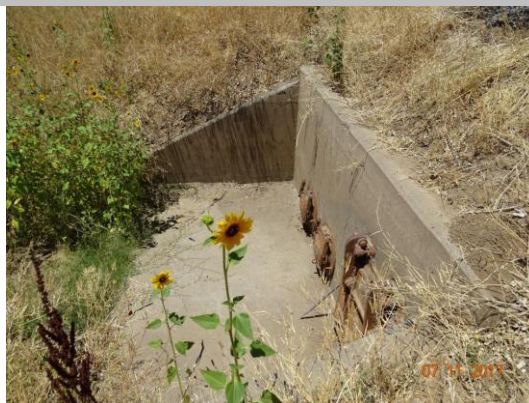
LM Start	0.00	Rating **	A	Issue No.	19
LM End	0.00	Issue Type +	Ma	Location *	
Category	Pump Stations			GPS Latitude/Longitude	
				Start	End
Item	Flap Gates			37.989633 °	37.989633 °
				-121.266933 °	-121.266933 °
DWR ID	DWR_NA0017_18_t_2012_19				
Action/Comments					
Inspector Comments: The flap gates appeared to be in good working condition.

View of the flap gates during 2018 inspection.

View of the flap gates during 2017 inspection.

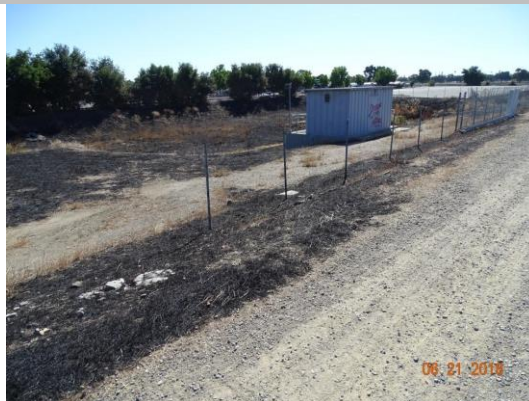
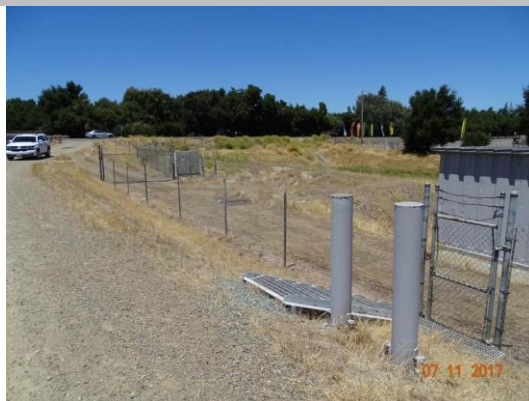
LM Start	0.00	Rating **	M	Issue No.	21
LM End	0.00	Issue Type +	Ma	Location *	
Category	Pump Stations			GPS Latitude/Longitude	
				Start	End
Item	Security Fencing			37.989633 °	37.989633 °
				-121.266933 °	-121.266933 °
DWR ID	DWR_NA0017_18_t_2012_21				
Action/Comments					
Inspector Comments: Part of the security fencing was missing due to recent vandalism. But, the plant building is secured. LMA has replaced fence within the past year and it was removed again.

View of missing fence links next to the pumping plant. Summer 2018

View of missing fence links next to the pumping plant. Summer 2017

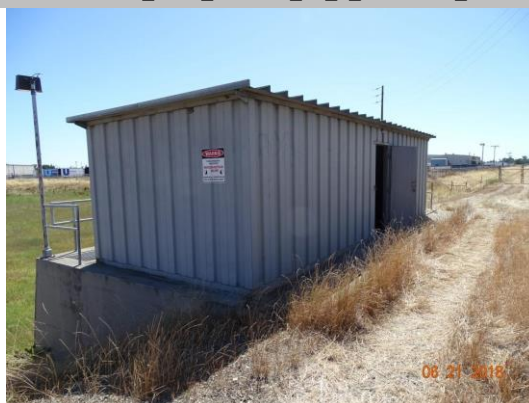
LM Start	0.00	Rating **	A	Issue No.	3
LM End	0.00	Issue Type +	Ma	Location *	
Category	Pump Stations			GPS Latitude/Longitude	
				Start	End
Item	Plant Building			37.982317 °	37.982317 °
				-121.249433 °	-121.249433 °
DWR ID	DWR_NA0017_19_t_2012_3				
Action/Comments					
Inspector Comments: The plant building was in good structural condition without any major deficiencies.

View of the pumping plant.

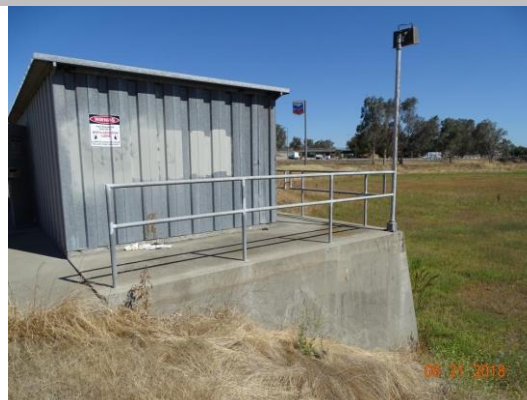
LM Start	0.00	Rating **	A	Issue No.	5
LM End	0.00	Issue Type +	Ma	Location *	
Category	Pump Stations			GPS Latitude/Longitude	
				Start	End
Item	Safety			37.982317 °	37.982317 °
				-121.249433 °	-121.249433 °
DWR ID	DWR_NA0017_19_t_2012_5				
Action/Comments					
Inspector Comments: No safety hazard was found around the structure. All hand rails were in working condition.

View of the hand rails around the pumping plant.

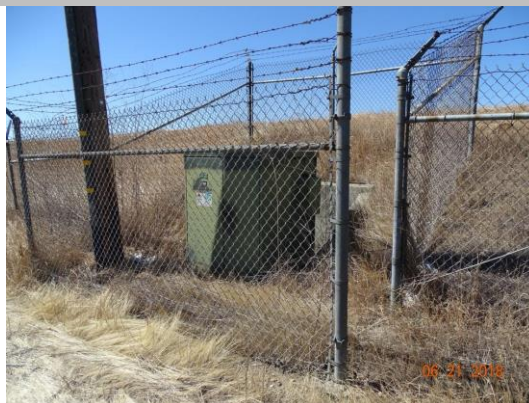
LM Start	0.00	Rating **	A	Issue No.	8
LM End	0.00	Issue Type +	Ma	Location *	
Category	Pump Stations			GPS Latitude/Longitude	
				Start	End
Item	Power			37.982317 °	37.982317 °
				-121.249433 °	-121.249433 °
DWR ID	DWR_NA0017_19_t_2012_8				
Action/Comments					
Inspector Comments: The power source appeared to be safe and reliable.

View of the power source used by the pumping plant.

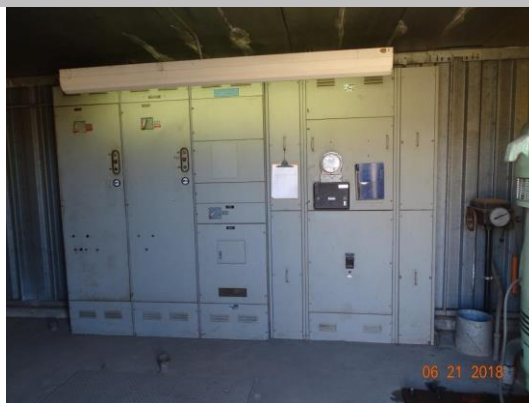
LM Start	0.00	Rating **	A	Issue No.	11
LM End	0.00	Issue Type +	Ma	Location *	
Category	Pump Stations			GPS Latitude/Longitude	
				Start	End
Item	Pump Control Systems			37.982317 °	37.982317 °
				-121.249433 °	-121.249433 °
DWR ID	DWR_NA0017_19_t_2012_11				
Action/Comments					
Inspector Comments: The pump control system is maintained and free of corrosion or any noticeable damage.

View of the power control system.

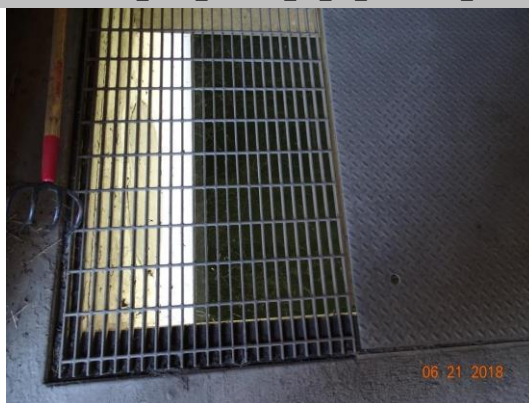
LM Start	0.00	Rating **	A	Issue No.	12
LM End	0.00	Issue Type +	Ma	Location *	
Category	Pump Stations			GPS Latitude/Longitude	
				Start	End
Item	Sumps/Wet Well			37.982317 °	37.982317 °
				-121.249433 °	-121.249433 °
DWR ID	DWR_NA0017_19_t_2012_12				
Action/Comments					
Inspector Comments: The wet well appeared to be clear of excessive debris or sediments.

View of the wet well.
